2001 SYSTEM ROOF DRYING VERIFICATION

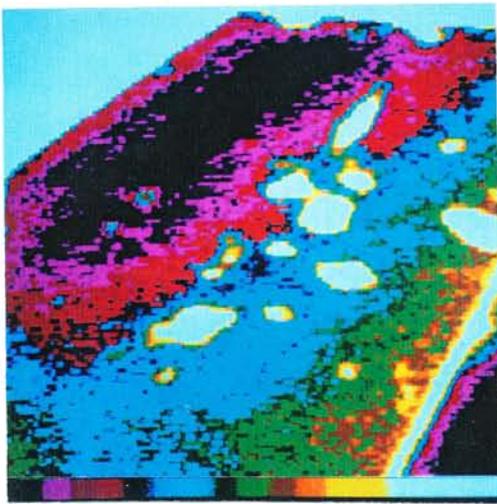
Infrared Picture Before

Hackettstown, NJ school district existing spray foam roof had **confirmed water saturation** in the areas marked from **infrared moisture survey**. Verifying core cuts revealed over **1 pint of water per square foot** entrapped in some areas of the existing spray foam roof.

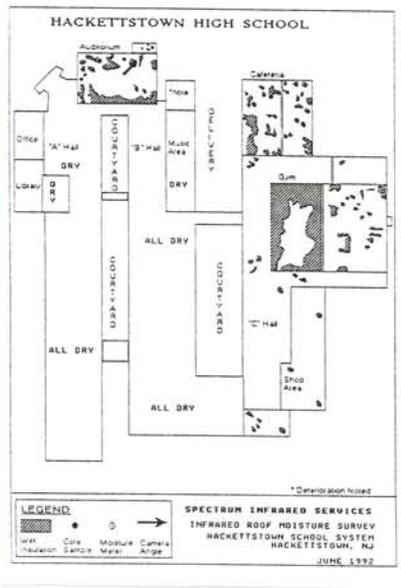
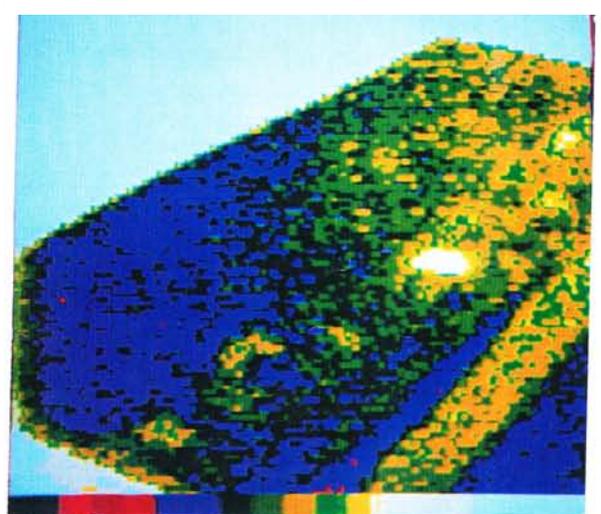
Reroofing With 2001 System 8 Months After

Infrared scan and physical rooftop investigation **8 months after** 2001 System installed verifying existing spray foam over **90% dry** with the **2001 wind vented roof system**.
