WET INSULATION MEETS ITS MATCH

Re: Scheman Building Moisture Survey Results

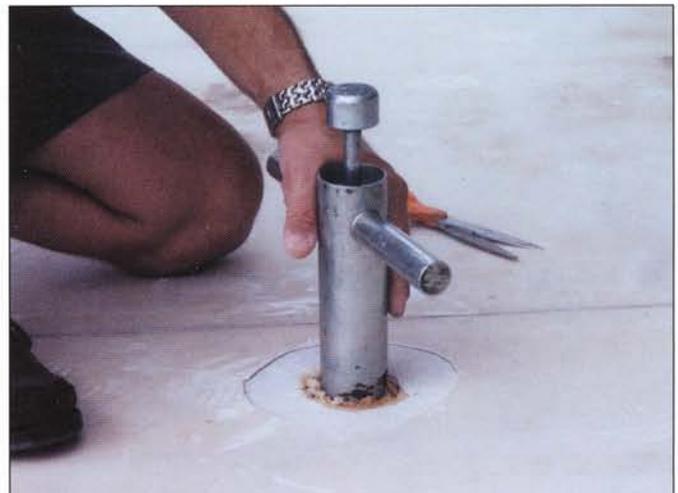
In May 2000, an infrared moisture survey was performed on the roof and it revealed four areas of potential wet insulation. Core cuts verified that these areas were indeed saturated. The wet areas covered 1,780 square feet of the 63,062-square-foot roof, or approximately 3 percent. By the fall of 2000, there were active leaks and many fasteners had pulled loose. On windy days, you could actually see the roof flutter.

Core cuts were made in two of the previously identified wet areas.

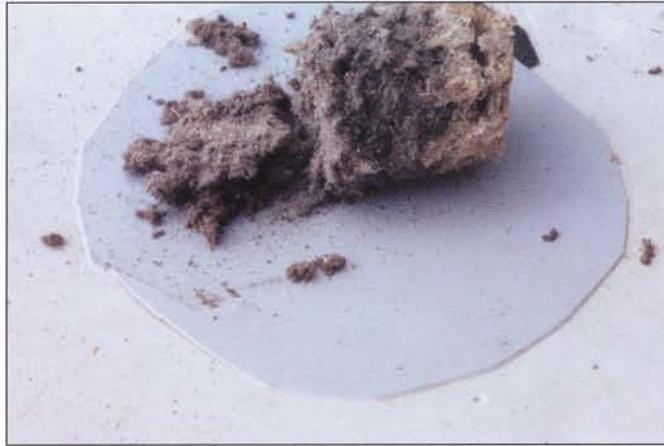
Core cuts show dry insulation.

"The insulation consisted of 1½ inches of perlite and ½-inch wood fiberboard directly below a Hypalon membrane," says Fogue. "The vapor barrier appeared to be a modified asphalt membrane consistent with a modified base sheet. Upon observation, and as can be seen in the photographs,

the insulation was completely dry."

Is Fogue convinced that it was the roofing system that caused the insulation to dry out? The answer, in a word, is yes. "Considering the location of the vapor barrier over the

existing deck below the insulation, the drying out of the wet insulation could only have happened upward and be directly attributed to the roofing system." Beyer agrees. "The fact that there is a vapor barrier on top of the metal deck attests to the system's ability to dry out an existing roof," he says. He attributes the

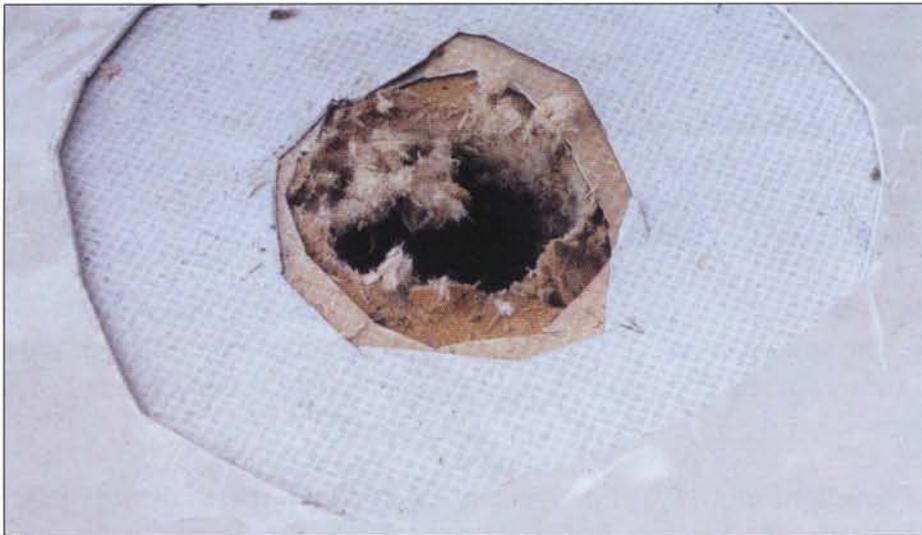
Cuts were made through the new membrane, existing Hypalon membrane and insulation, down to the vapor barrier over the existing deck.

Cuts were made through the new membrane, existing Hypalon membrane and insulation, down to the vapor barrier.
