## **NRCC Guarded Hot Box Testing (ASTM C1363-97) for Energy Efficiency of a Total Roof Assembly**

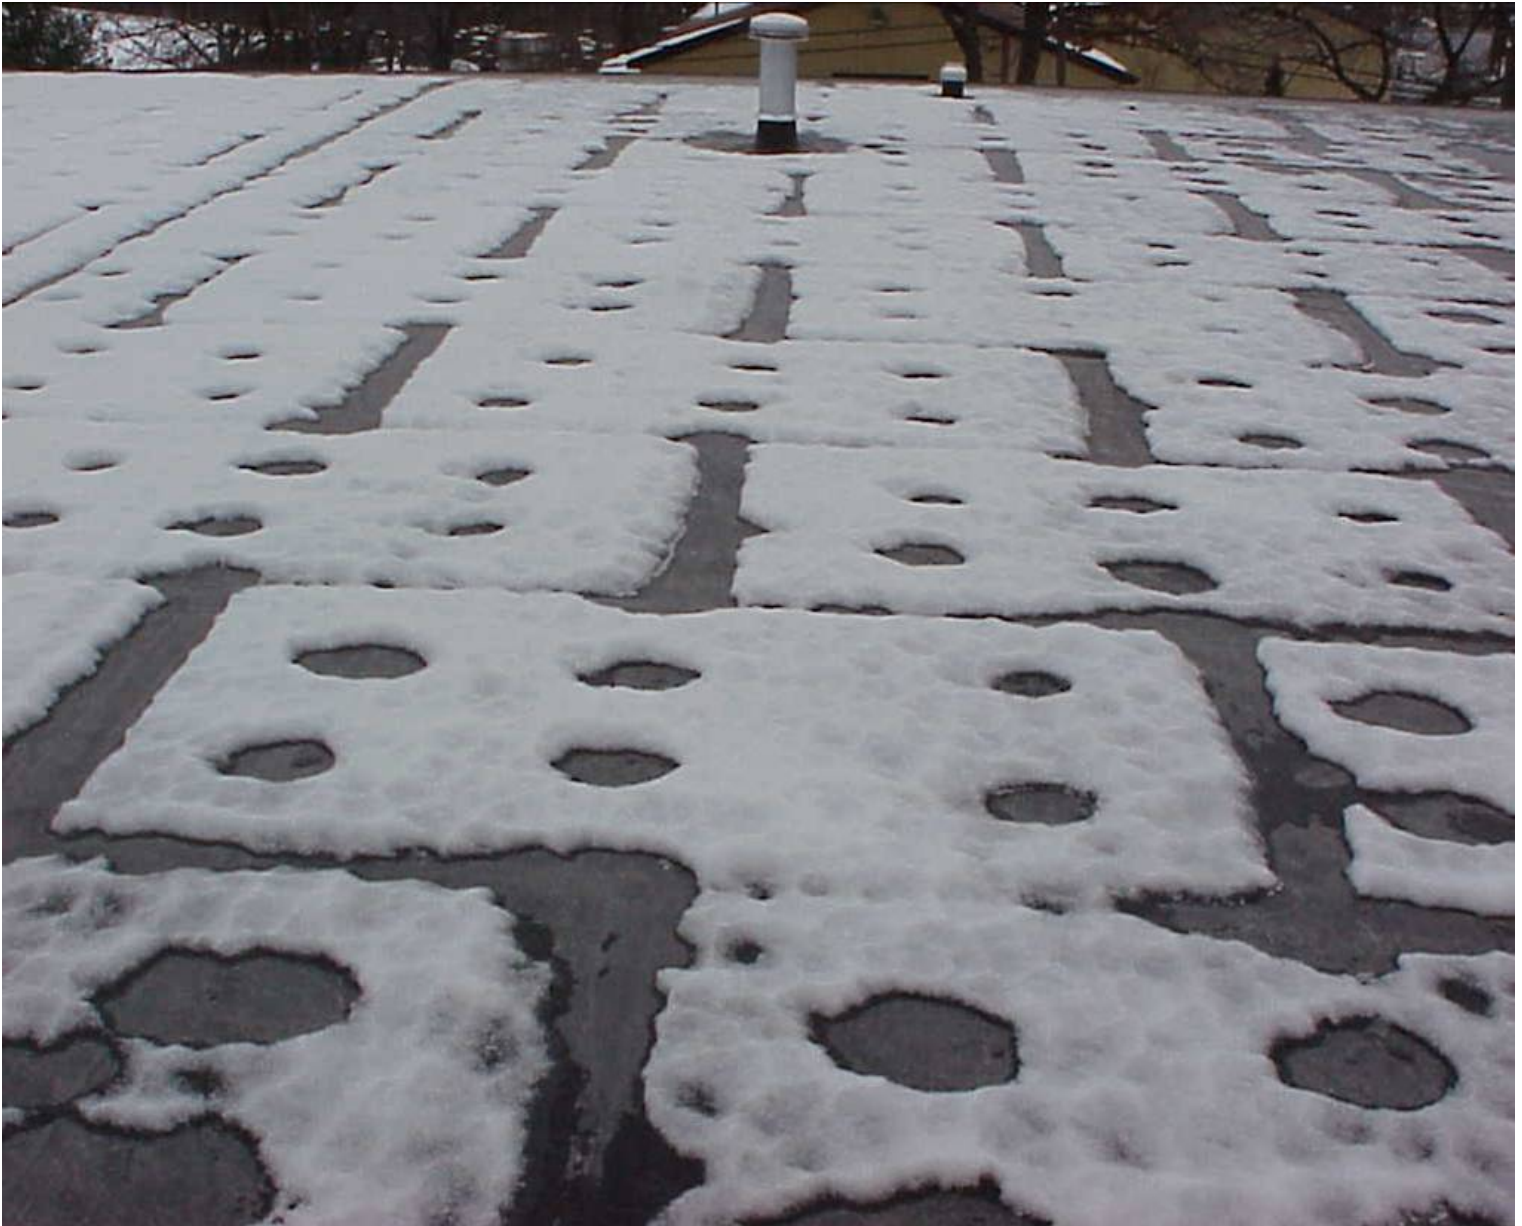
Figure 23 below shows a 2001 Company roof where snow melt occurred over insulation joints from convection air currents and thermal transmission from mechanical fasteners on a totally adhered EPDM over a single layer of 3" ISO with six fasteners per board.
