2001 SYSTEM ROOF DRYING VERIFICATION

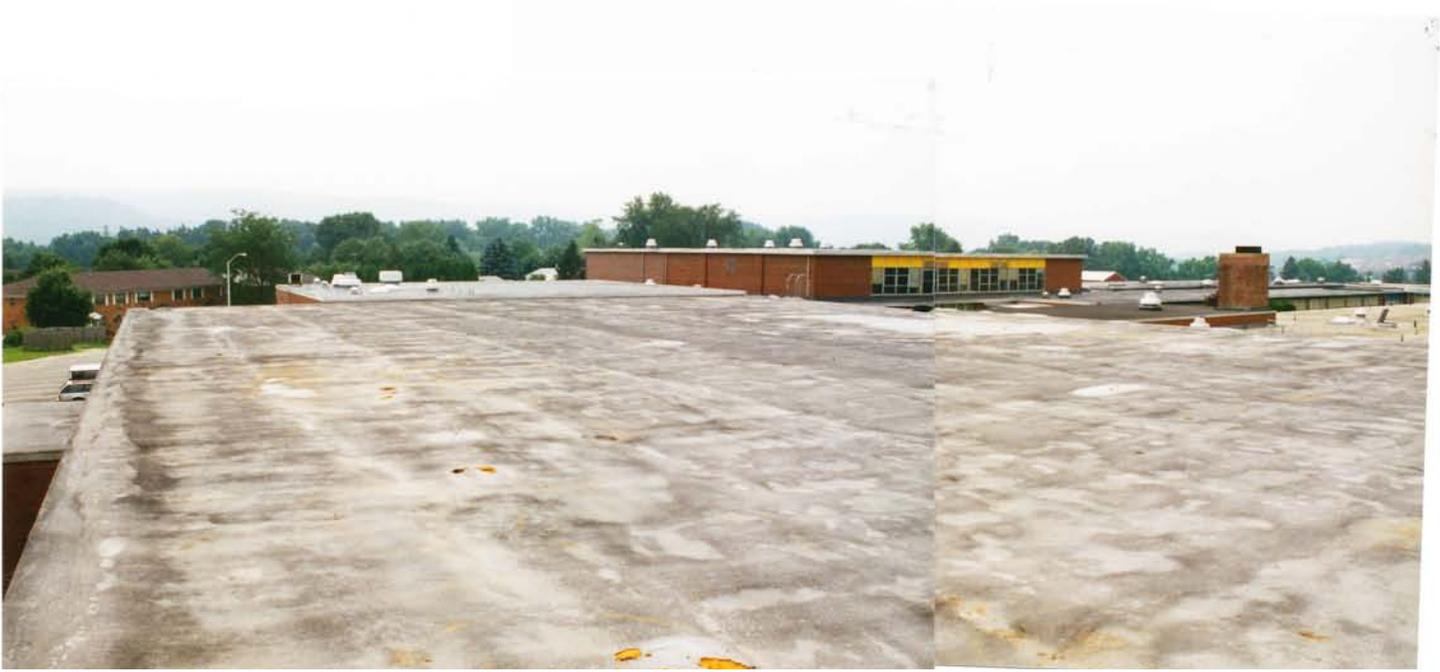
Infrared Picture Before

Hackettstown, NJ school district existing spray foam roof had **confirmed water saturation** in the areas marked from **infrared moisture survey**. Verifying core cuts revealed over **1 pint of water per square foot** entrapped in some areas of the existing spray foam roof.

Infrared scan and physical rooftop investigation **8 months after** 2001 System installed verifying existing spray foam over **90% dry** with the **2001 wind vented roof system**.

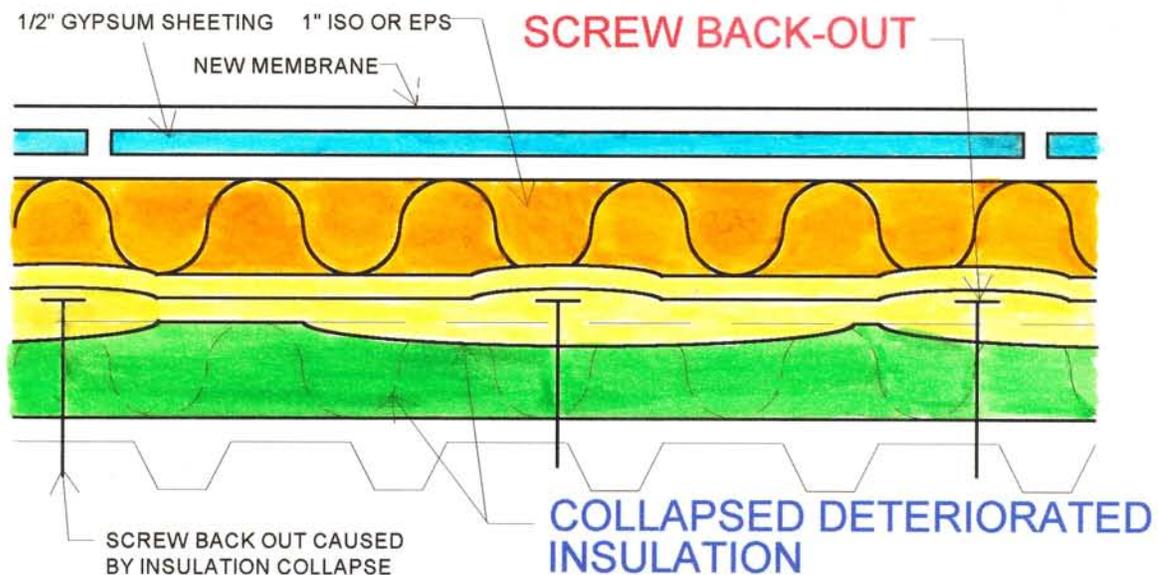
3.) Fastener Backout:

Should the existing wet insulation collapse, once dried, screws used to fasten the old roof or new roof would work themselves up into the waterproofing membrane breaking through from the underside.

SOLUTION WITH A LOOSE LAID 2001 SYSTEM

In these collapsible substrate situations, a **1" layer of plastic insulation ISO or EPS** could be placed over the existing **roof surface to absorb the screw head rise**. A loose layer of 1/2" Gypsum sheeting is placed over the 1" plastic insulation to hold it in place, offsetting the underside insulation joints 2' in each direction.
