2001 Co. Severe Hail Damage Testing

Koontz Associates Engineering Hobbs New Mexico

An Air Gun Shoots 1", 2", or 3" Hail Balls at a roofing

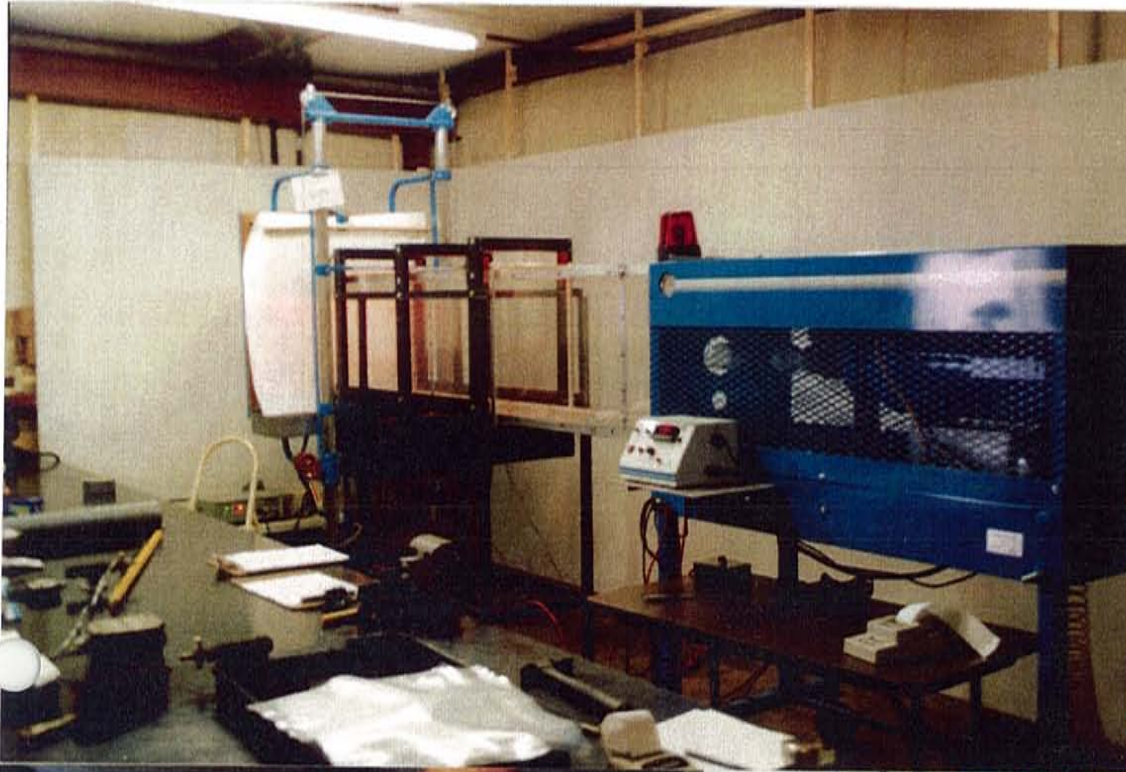
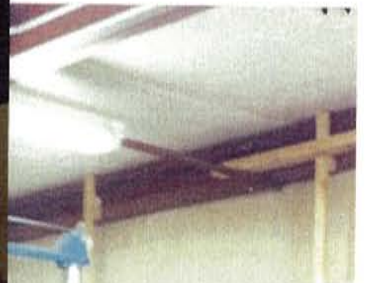
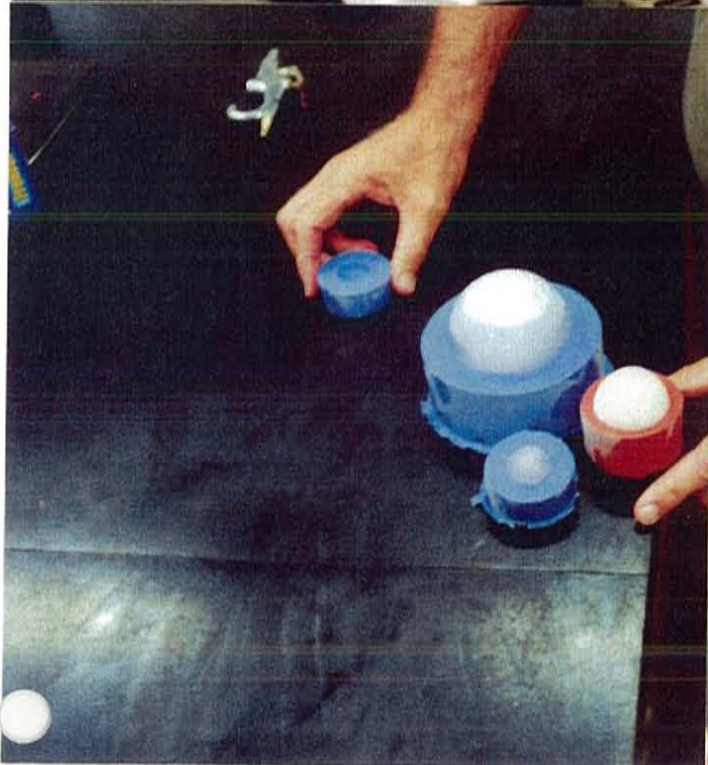
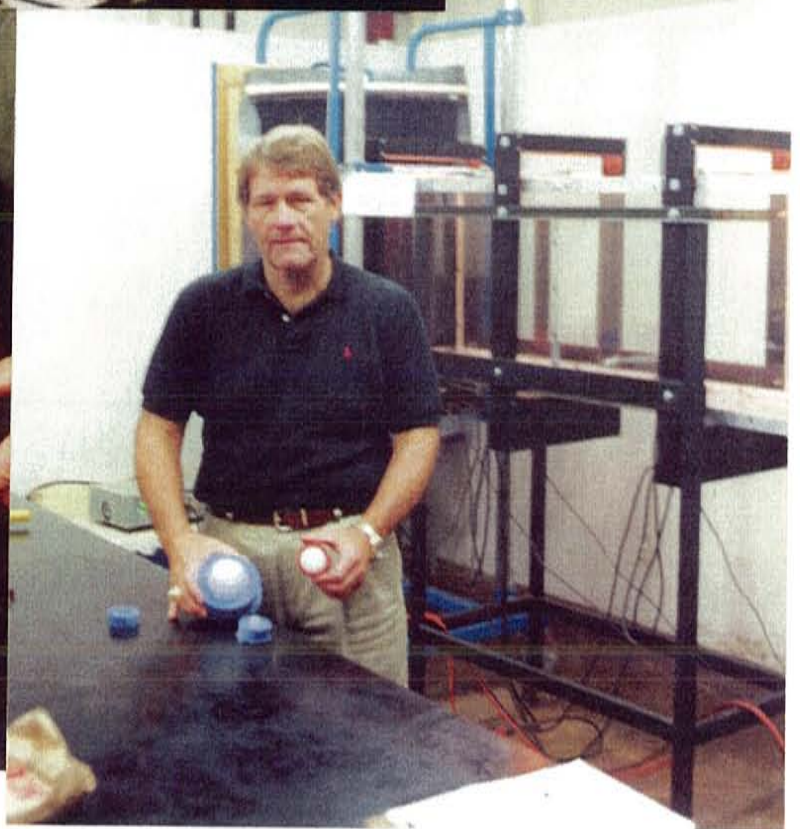
Membrane
And substrait
chilled to

36° to 40°F

At 60 mph

90 mph

120 mph

150 mph

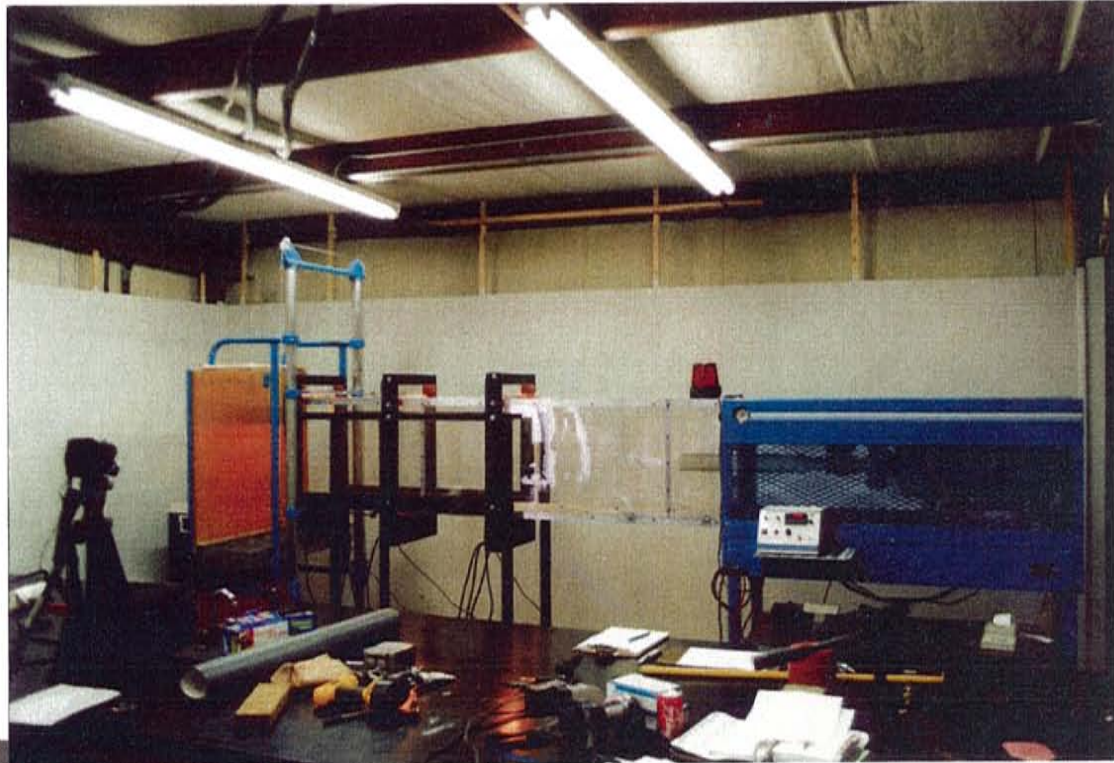
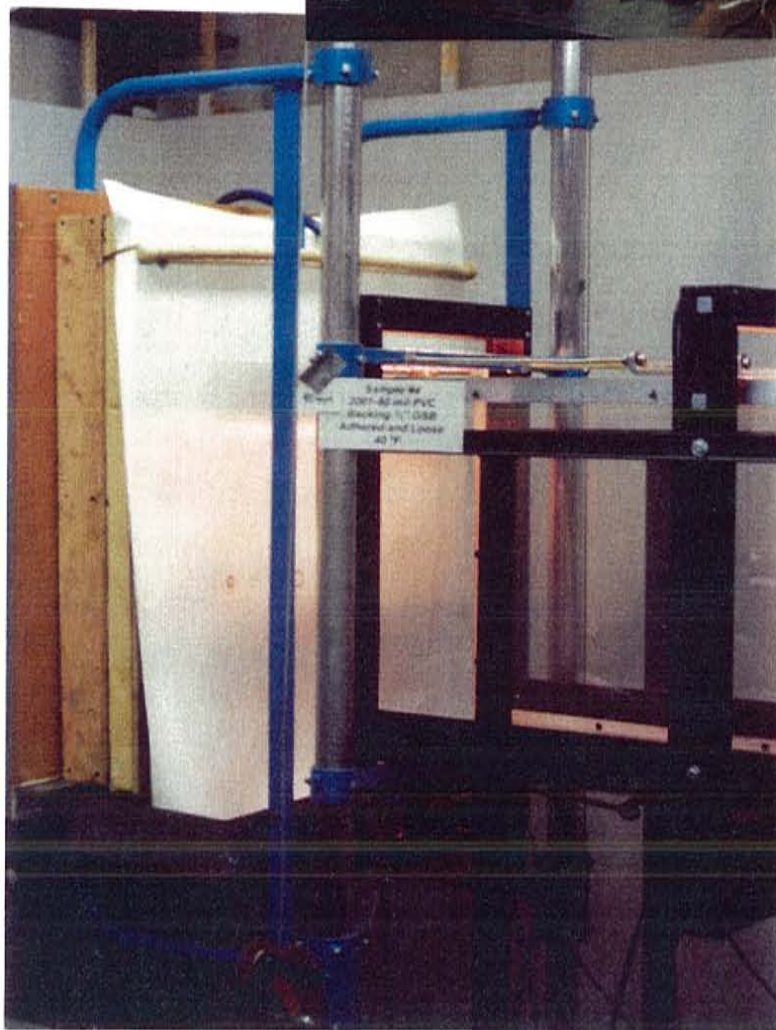
The Koontz engineering hail gun shoots various sizes hail balls at a cooled 38°F roof assembly surface

An air cannon above shoots a hail ball through a 10" speed recording chamber at a roof surface

Notice how the PVC roof membrane is cooled with a spray of 38°F water.

The hail impact area is forensically examined for damage and the results are reported accordingly.

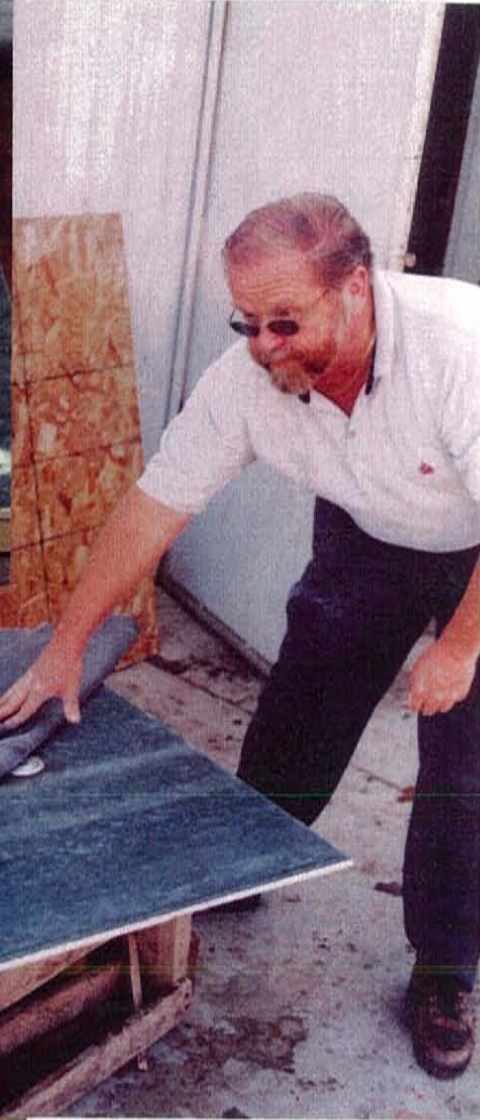
Over 3" Hail at 90 to 120 mph
On loose 1/2 Dens Deck over
2" ISO with 90 mill plus C-EPDM

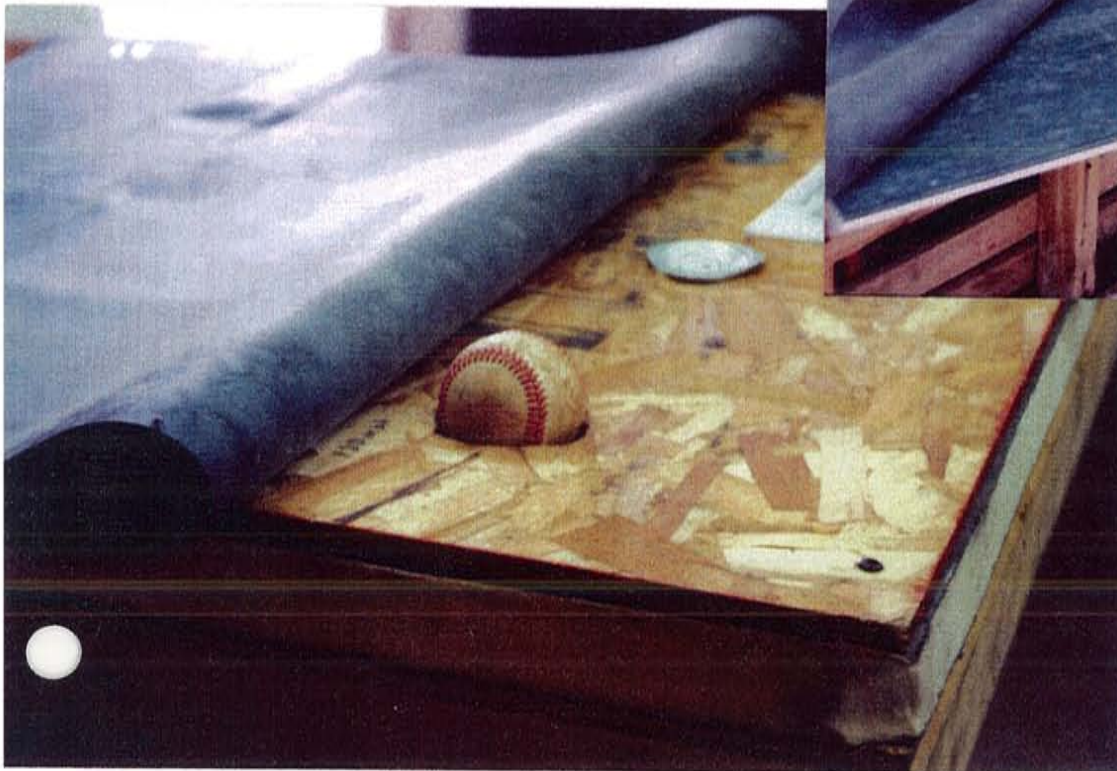
Notice 3" hail
impact into
1/2" OSB water
board at 120
miles per hour
No C-EPDM
Damage.

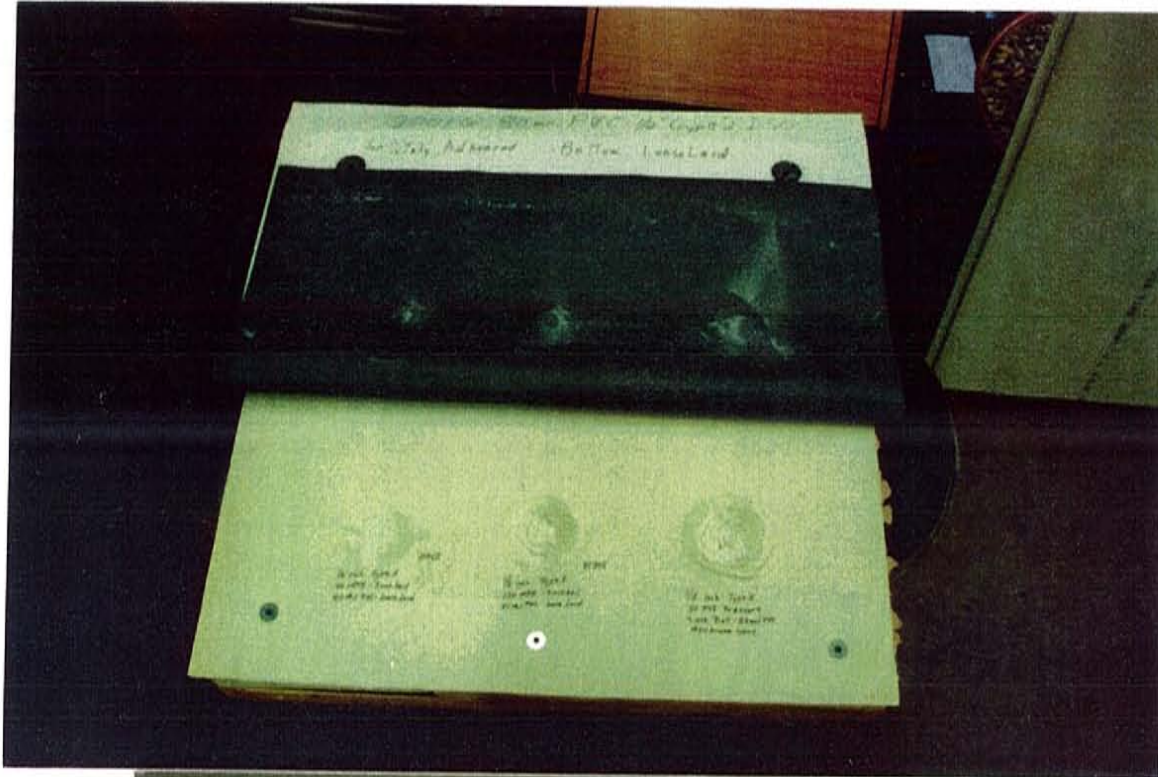
80 mill Reinforced PVC over 1/2 " Gypsum

90 mph
120 mph
150 mph
Miles per
Hour

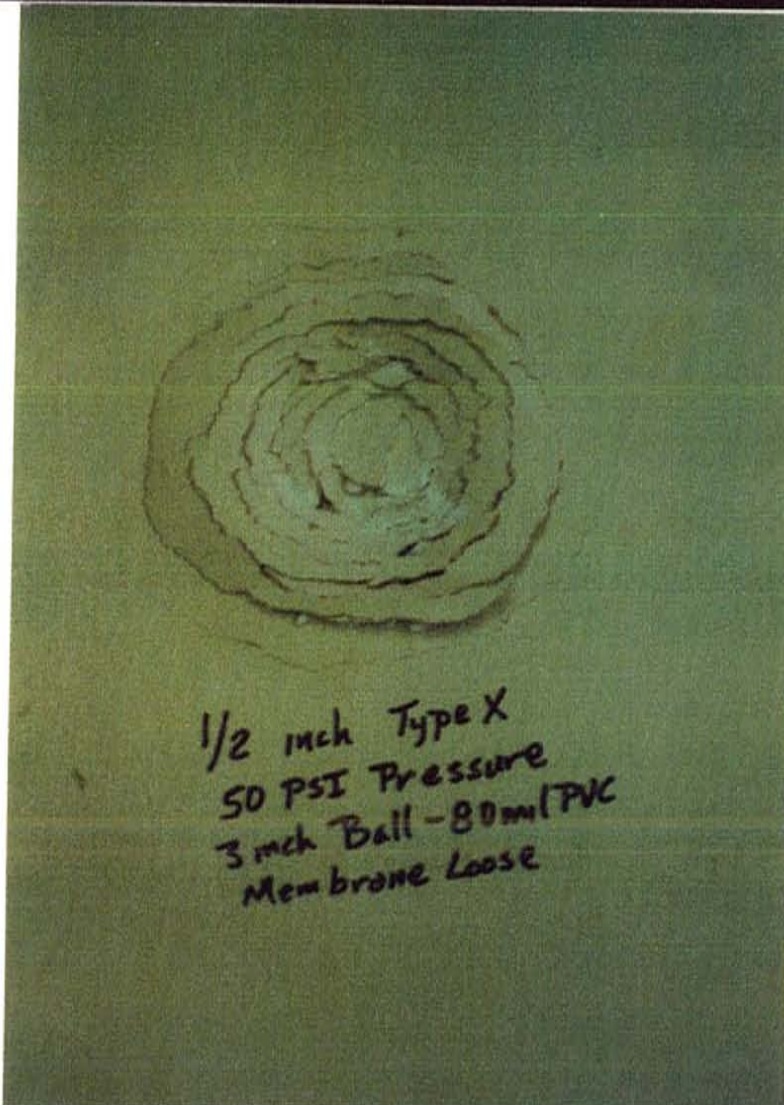
The hail ball impact into the 1/2 gypsum on 2" ISO acts like a catchers mitt and crushes in concentric rings adsorbing the impact energy of the hail ball and the 2" ISO has sufficient elasticity to be pushed in and then push out the gypsum impact energy.

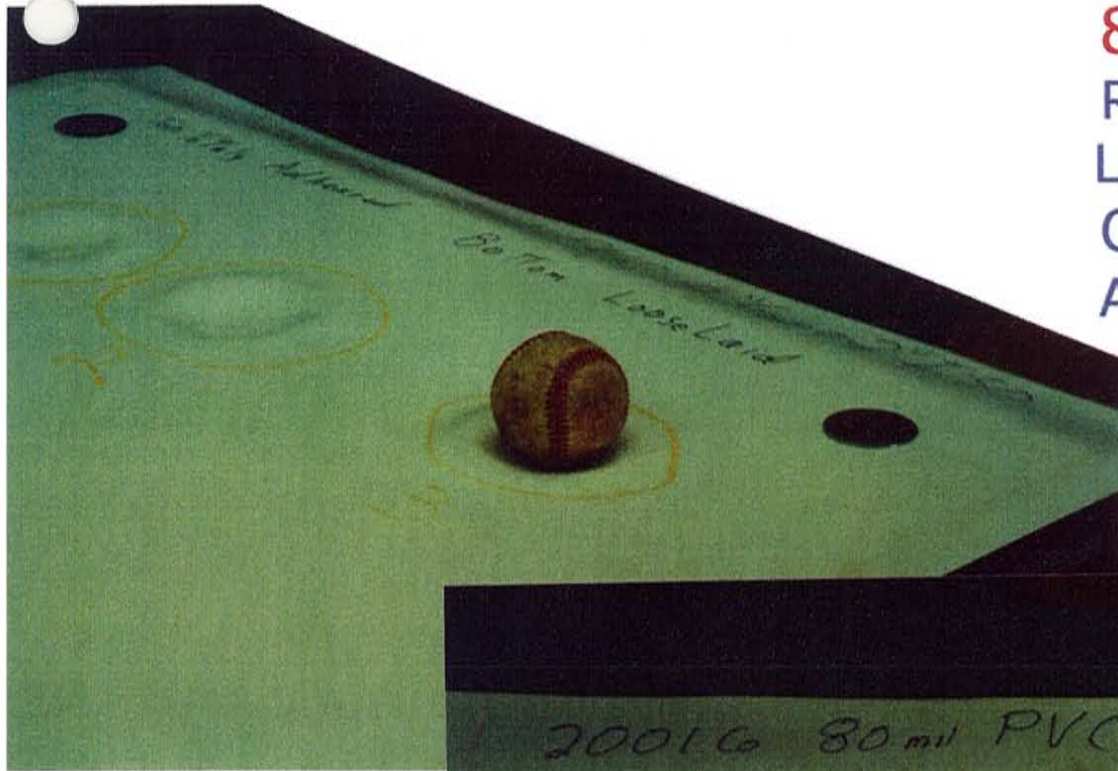
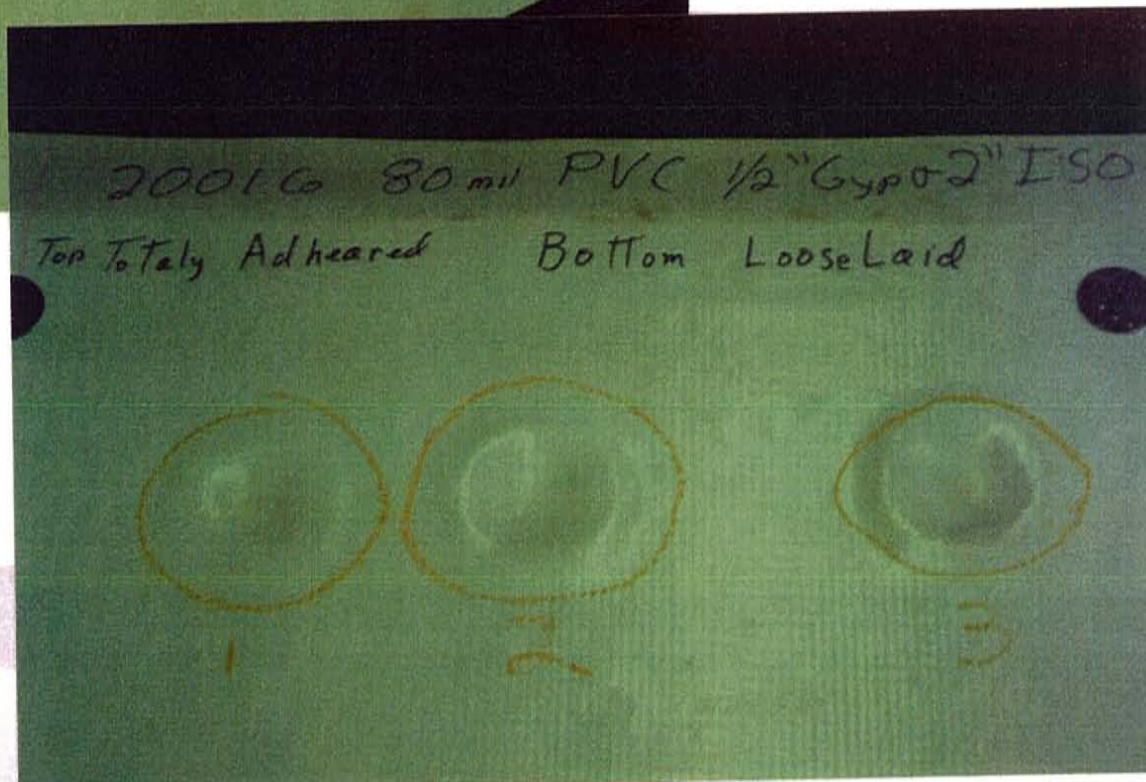
2" Hail Resistance of 2001 Co.

80 Mil PVC

Roof Membrane

Loose laid

Over 1/2" Gypsum

And 2" ISO

2" Hail Impact
At 60 mph
90 mph
120 mph

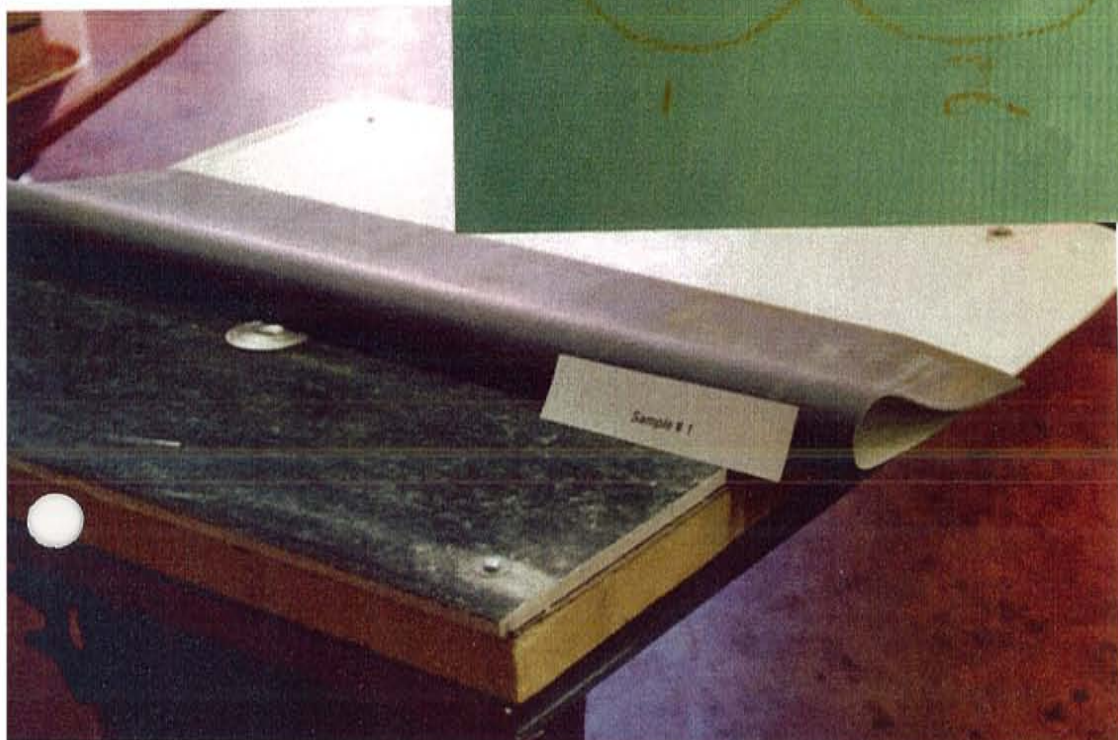
2001 Co.
Offers 2" Hail
Warrantee Rider
With 80 mil
Or Thicker PVC

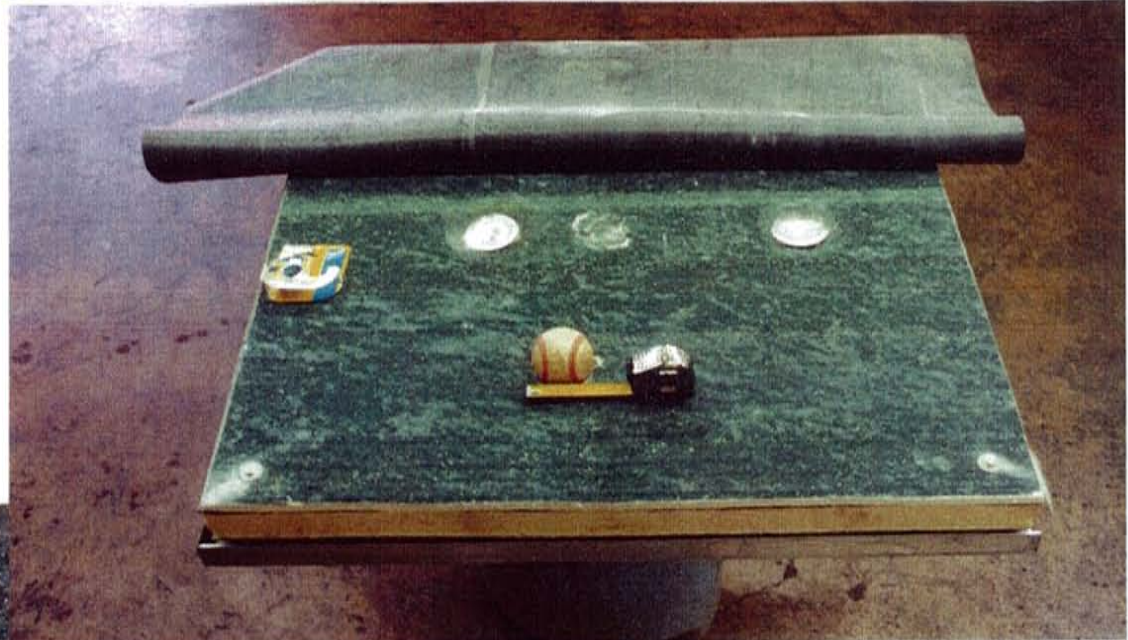
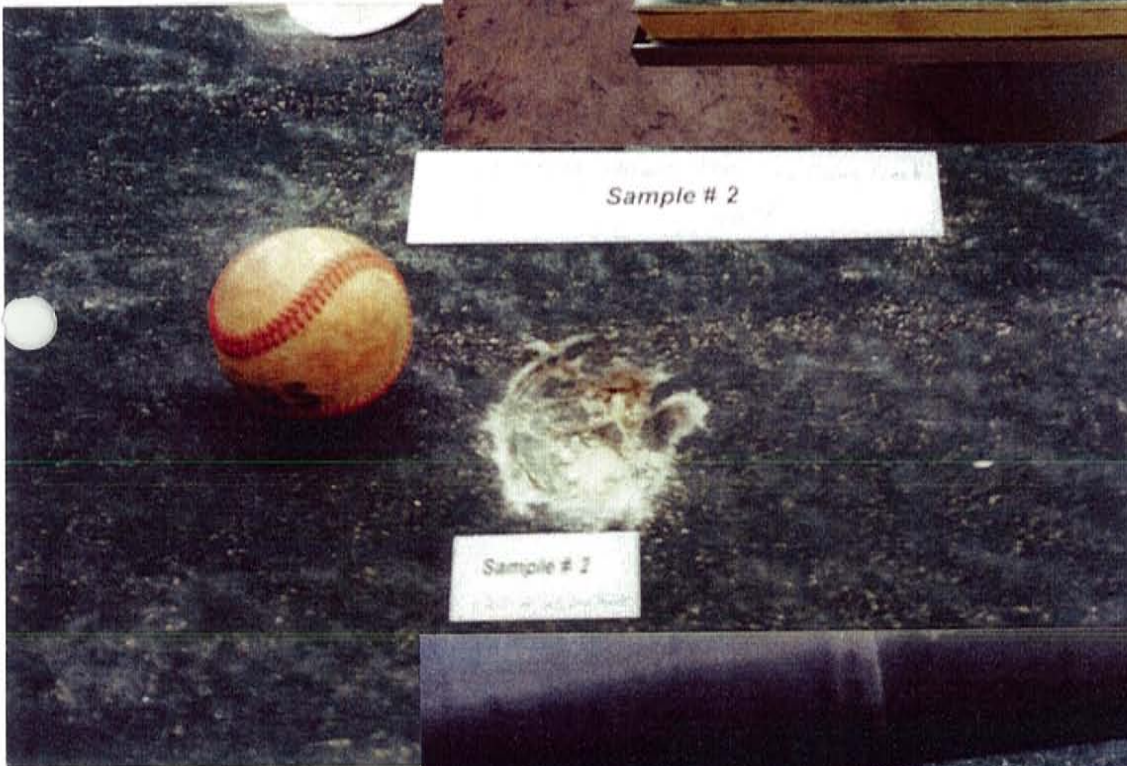
90 mil C-EPDM hit on fastener

Washers
Shows no
Membrane
Damage

3" Hail
Shot at
120mph

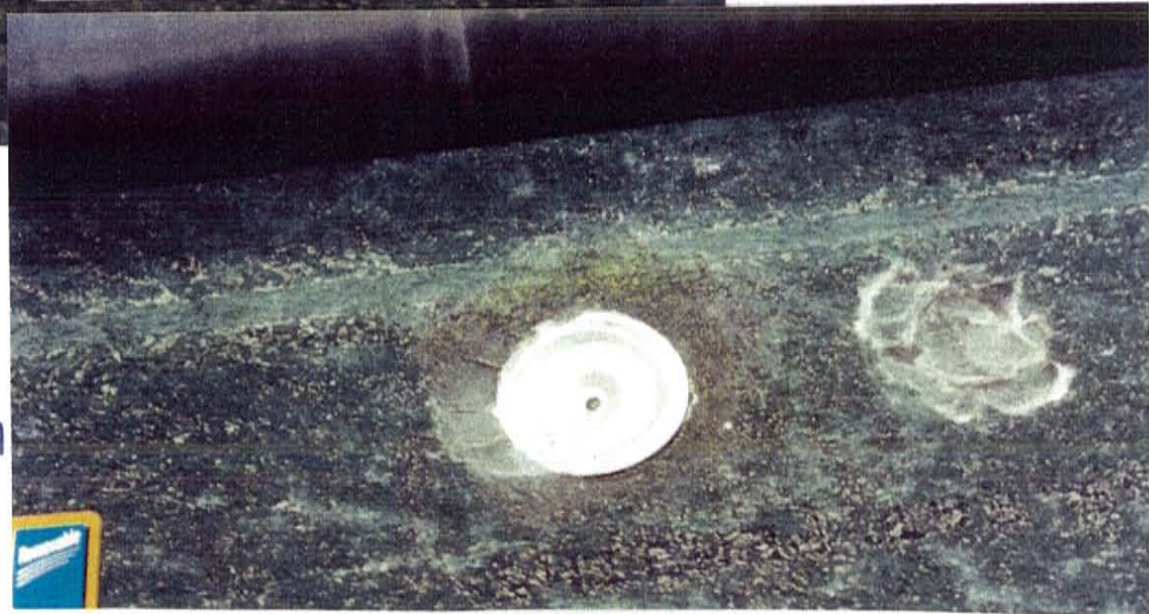
C- EPDM
90 Mil +
1/2" Gypsum
2" ISO
