# Roofing Contractor

# Project Profile: 94 Dodge Place

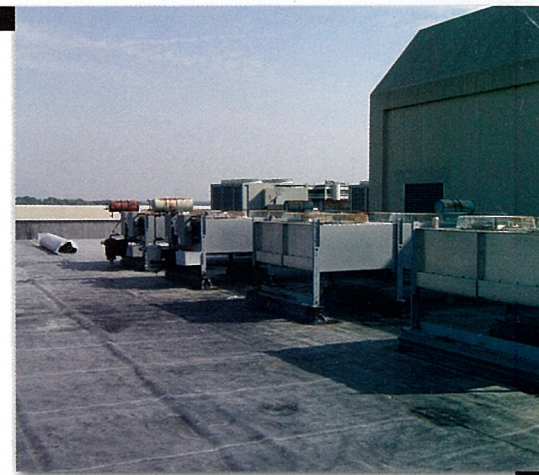
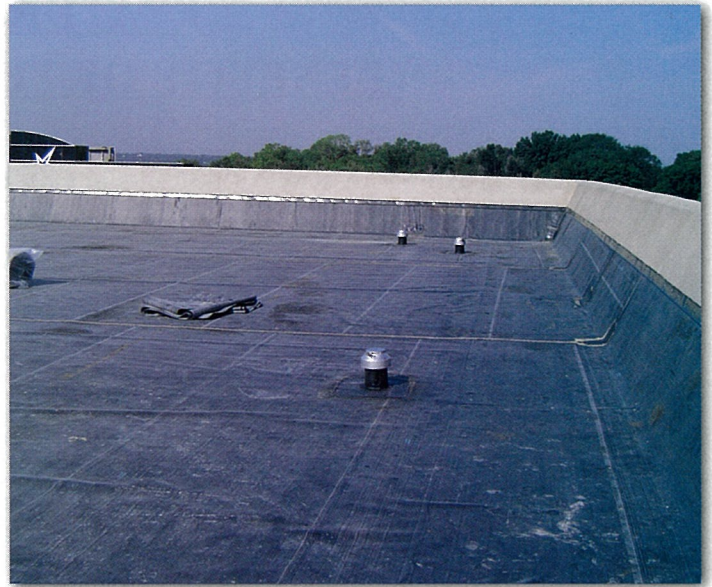
Lower Roof Square Footage	34,182
Upper Roof Square Footage	3,978
Total Square Footage	38,160
Large Rooftop Units	11
Curbs	14
Penetrations	26
Exterior Perimeter Linear Feet	1,148
Interior Edge (expansion joints)	784
Total Edge	1932
