# Sears Warehouse in Brooklyn New York

**2001 Co. C-EPDM Wind Vented Roof Assembly Over Existing Smooth Surface BUR**

**2001 Co. Wind Vented EPDM Reroof System Sears Warehouse in Brooklyn, New York**

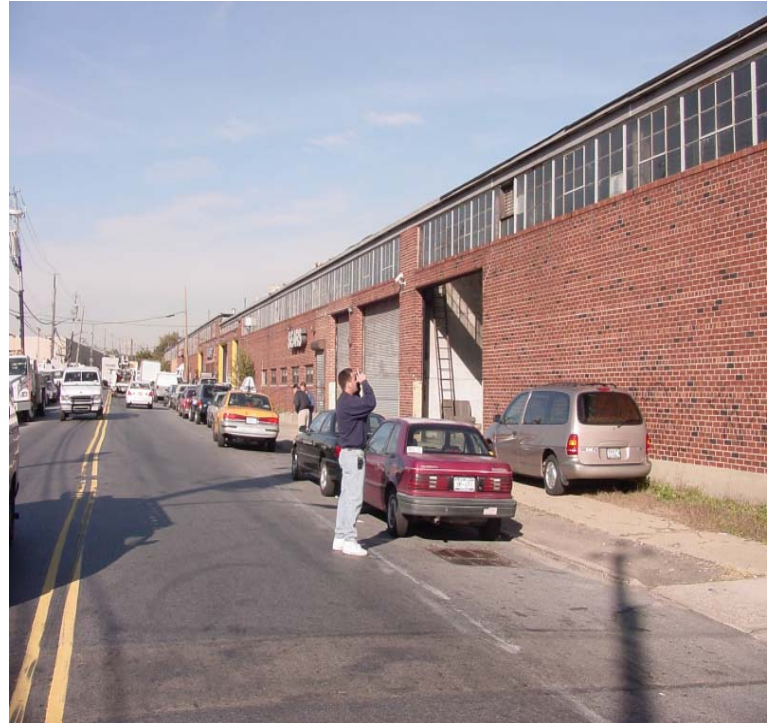
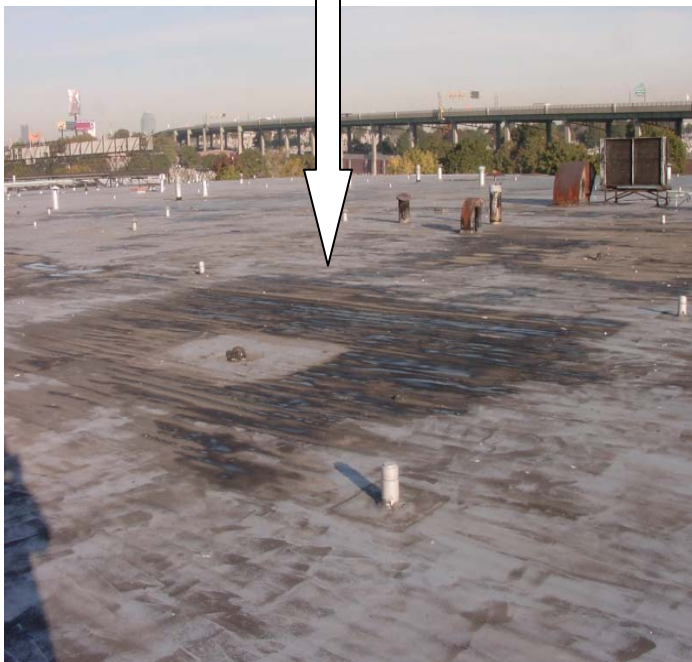
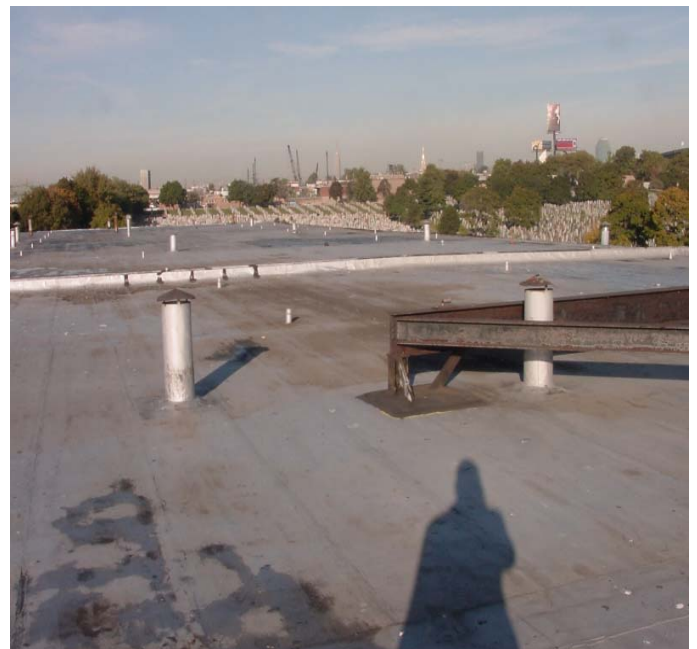
The existing 15-year-old smooth surface modified bitumen roof was leaking throughout the 200,000 square foot facility.

Many areas of ponding water existed throughout the building organically decomposing the asphalt waterproofing membrane. Many pieces of damaged and nonfunctional roof top equipment were removed.

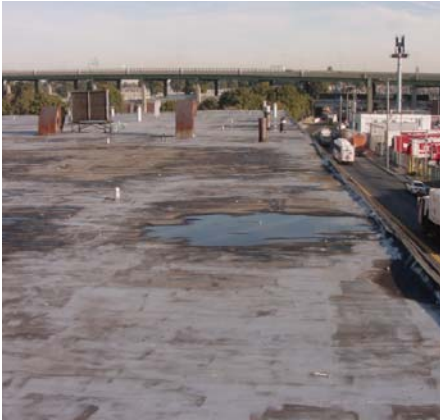
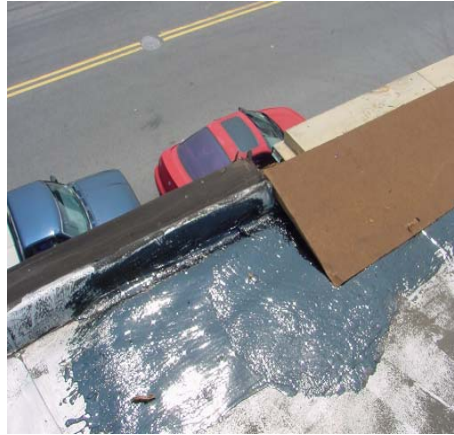
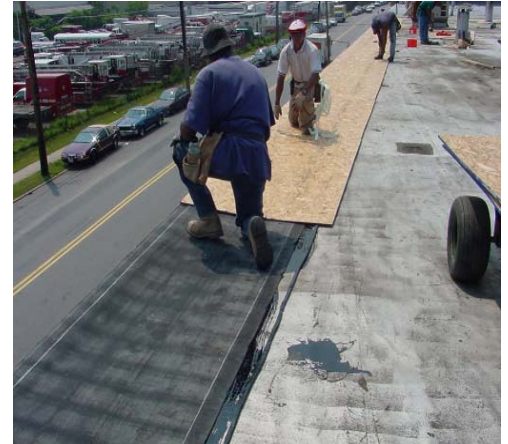
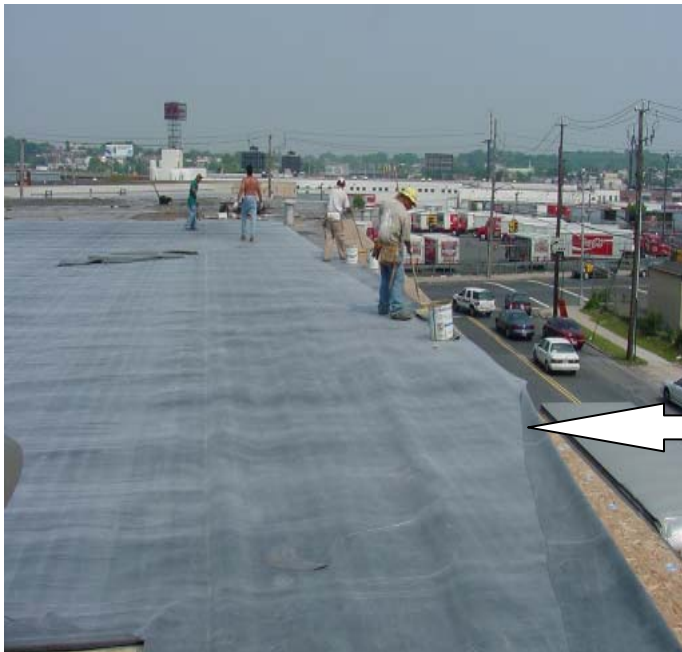
The entire perimeter wood nailers had rotted out and needed to be replaced. Since propane is no longer allowed on rooftops in New York, the perimeter nailer edge was rebuilt and tapered insulation was hot mopped to the existing smooth surface BUR. The tapered edge was covered with a base ply to rebuild the perimeter edge. The perimeter was air sealed with air seal rope and compressed with OSB wafer board, which was then fastened to the 22 gauge steel deck.

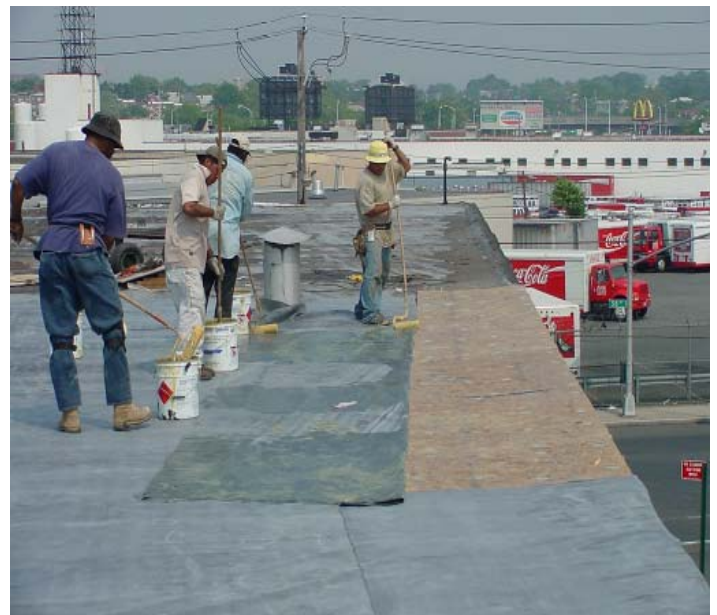
50 ft x 150ft rolls of 2001 C-EPDM were then loose laid over the repaired perimeter edge. With such a wide-open area, the 2001 loose laid wind vented roof can cover huge areas in a relatively short time period.

Because of wind code requirements, 4 feet of OSB is fastened to the perimeter edge to increase the wind uplift resistance to 100 mph. The field membrane is adhered to the OSB by using 2001 bonding adhesive.

The field membrane is adhered over the nailer vertical surface encapsulating the perimeter edge, which will prevent the edge from rotting again in the future and sealing out lateral wind flows in the roof assembly.

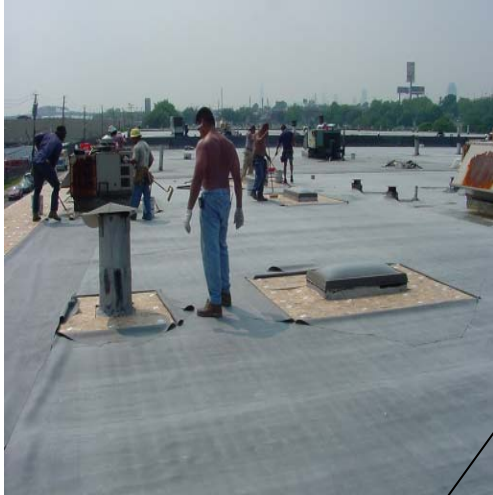
Penetrations are also surrounded with air seal rope and compressed to the existing roof with mechanically fastened OSB boards. The field membrane is adhered to the OSB and up the penetration wall as a self flashing. This creates both an air and water seal.

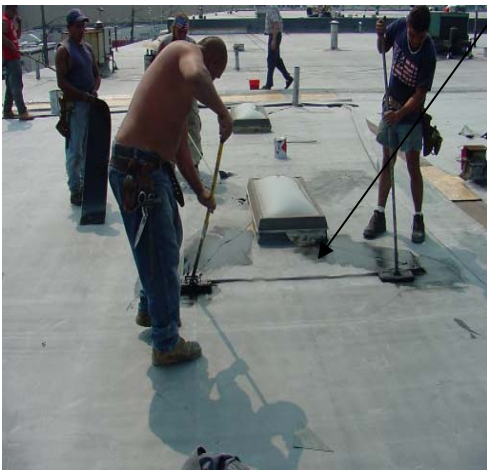
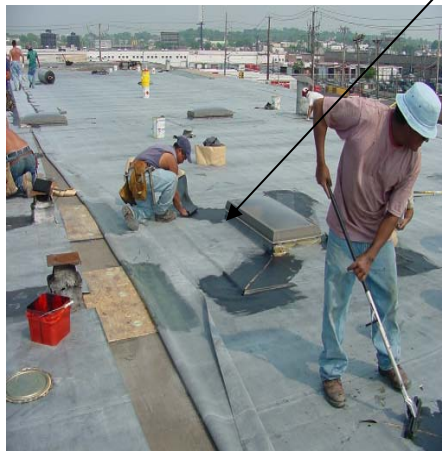
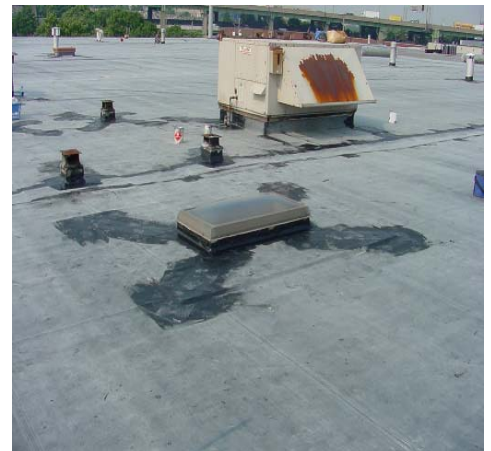
The pie cut area is cleaned with gasoline and 2001 “talc eater.”

2001-cover tape is applied at pie cuts on field membrane to the OSB.

9 in. cover tape is put down.

The unit is completely flashed to be watertight

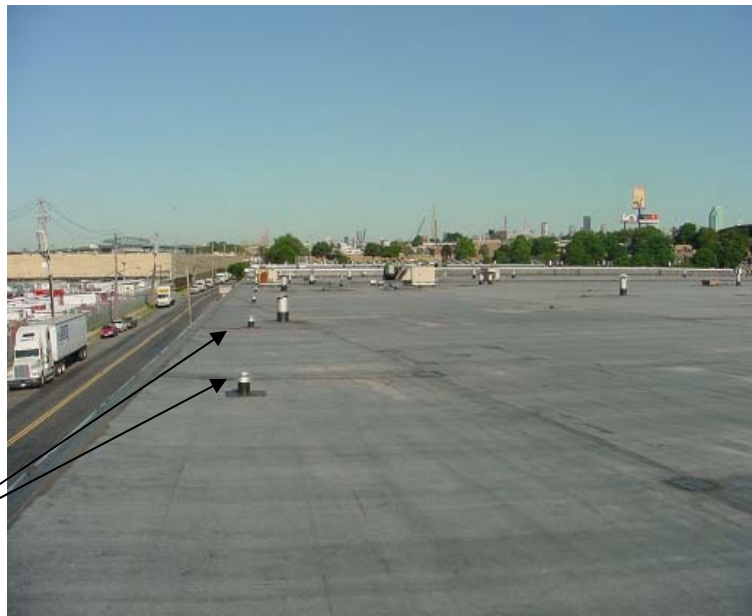
The large, wide-open nature of this roof made it ideal for large rolls of EPDM. (50 X 150) were put down rapidly and easily.

The limited number of seams allowed for quicker installation. Ballasting this roof with 1” or 2” gravel would have been a total nightmare, and the building structure would not carry the ballast weight

Notice the equalizer valves placed every 30 feet or less around the perimeter. They are the key element in a 2001 system. They equalize the low pressure of the wind vortex and literally suck the roof to the monolithic deck.

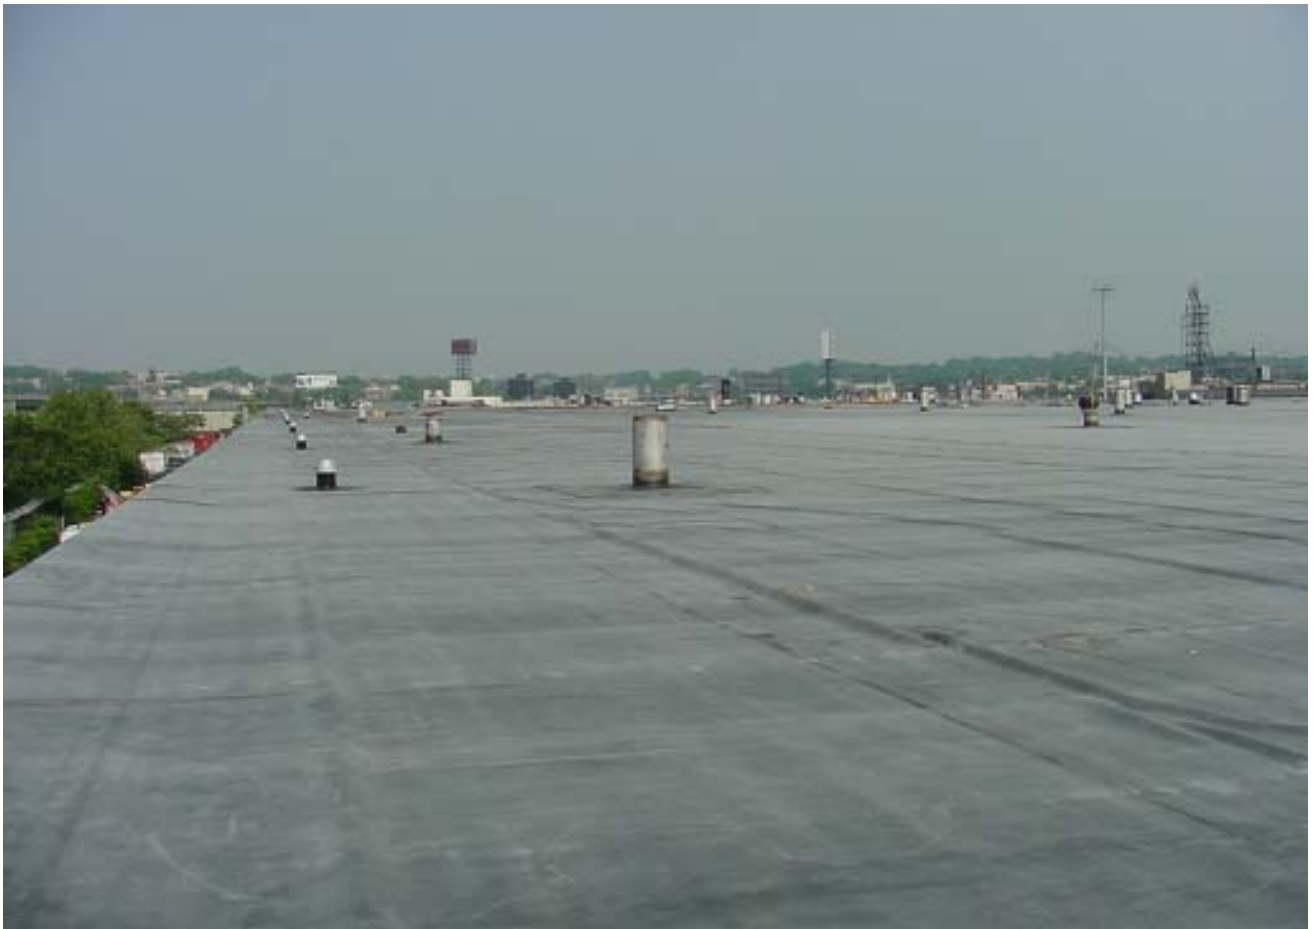
The 2001 re-roof system vents moisture out of the roof assembly, thus drying out the existing wet roof. This saves money by not requiring a complete tear off of the existing roof assembly.

A good crew under competent leadership installed 200,000 sq. ft. in 13 days!!! If the reroof system was totally adhered, or mechanically fastened, the time of installation would have doubled. Building owner saved 30% with 2001 Wind Vented Roof.
